Rimkus Consulting Group, Inc.
Eight Greenway Plaza, Suite 500
Houston, TX 77046
(800) 580-3228 Telephone
(713) 623-4357 Facsimile

Re: RCG File No: 11009971
LLV Number: 0209452
VMF Location: 1530 Greensmark Drive in Houston, Texas
Subject: Final Report

Rimkus Consulting Group, Inc. was retained to examine LLV 0209452, VIN 1GBCS10E4M2908832. The fire occurred on June 13, 2016 at around 12:30 P.M. the operator of the vehicle at the time of the fire, was unavailable for interview but reportedly stated the vehicle's engine died while delivering mail on his route and backfired during subsequent attempts to restart it. Soon thereafter, smoke was observed from beneath the hood as well as flames.

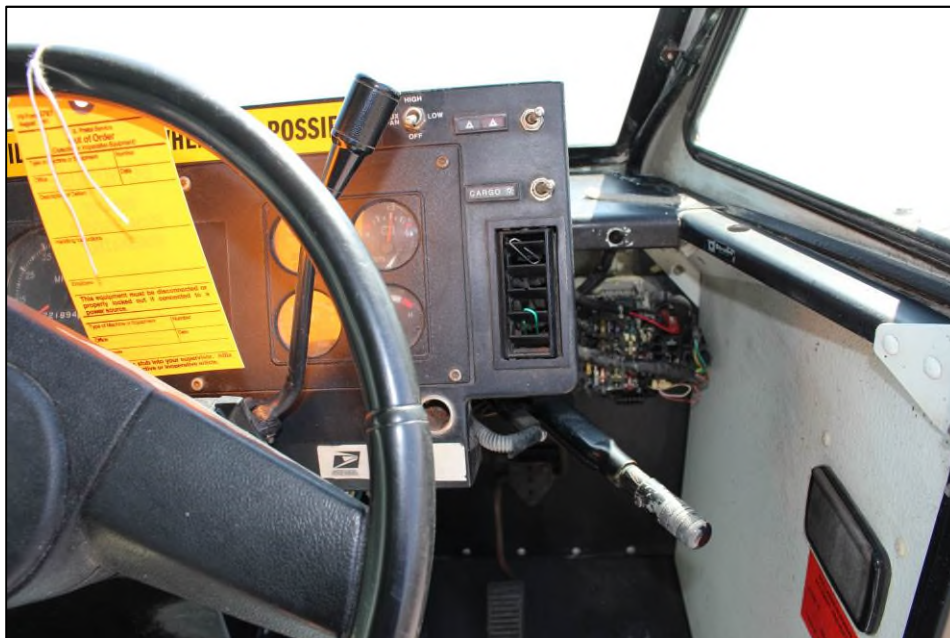
Photograph 8
Fuse panel area in corner.

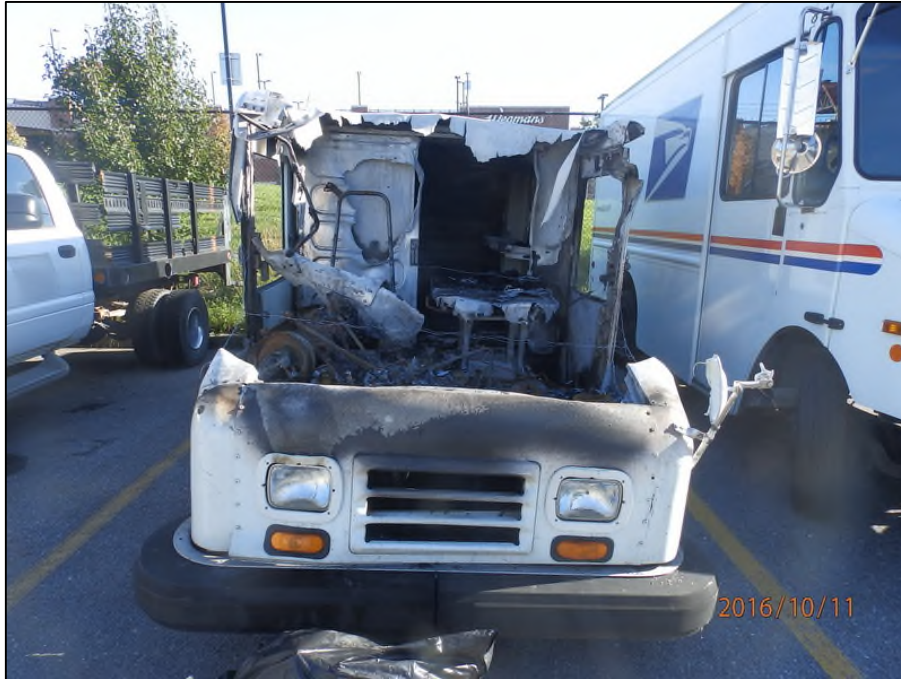
Photograph 1

The exterior front of the vehicle sustained fire, heat and smoke damage. The front panel sustained heat and smoke damage above the grill and headlight assemblies. The hood, front support posts, and front windshield were no longer in place. The hood had been removed prior to our inspection. The front panel sustained smoke damage above the headlight assemblies. The exterior left side sustained fire and heat damage from the front bumper to the rear of the sliding door. The front fender had been consumed above the engine and the rear portion of the left wheel and tire. The door had sustained fire damage up to the roof line. The exterior rear sustained fire and heat damage to roll up door and bulkhead. The exterior right side sustained fire damage from the front bumper to the driver door. The front fender had been consumed above the right front wheel and tire. The roof had been consumed above the passenger compartment. It was intact above the cargo area.

A view of the front of the vehicle.

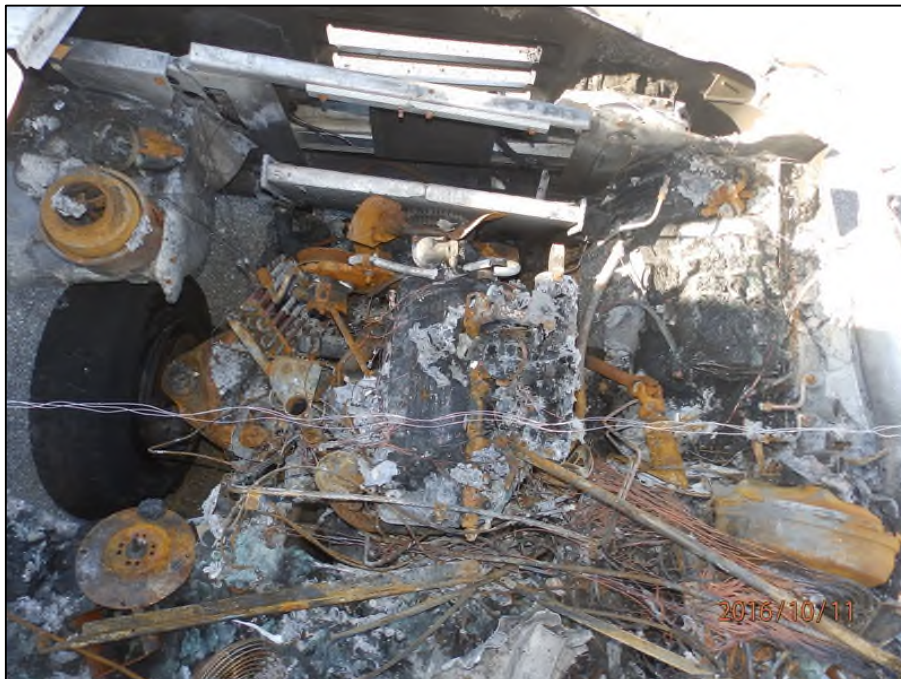
Photograph 2

engine compartment sustained fire, heat and smoke damage throughout. The damage was most severe on the left side of the engine compartment. The power steering unit sustained fire damage. The flexible lines and reservoir had been consumed. The aluminum dome cover on the right side of the engine compartment above the fuel rail had melted. The upper radiator hose on the left side of the engine compartment had been consumed. A portion of the serpentine belt had survived the fire. The brake booster positioned on the right rear bulkhead sustained fire and heat damage and had become detached from the bulkhead. The brake fluid reservoir had been consumed. The melted remains of the fuse box from the passenger compartment and the attached wiring harness were inspected. The wiring harness sustained fire and heat damage. The insulation had been consumed. Beading on one conductor within the wiring harness was observed. The alternator sustained severe fire and heat damage. The insulation had been consumed from the conductors to the alternator. The main conductor was secure with no evidence of adverse electrical activity. The auxiliary conductor was secure. The section of the auxiliary conductor attached to the alternator was approximately six inches long and the end displayed heat and mechanical damage. The top of the battery case had been consumed. The conductors had become detached from the terminals. The negative conductor was attached to the frame and to the block. The main positive conductor was attached to the starter. The insulation had been consumed but displayed no evidence of adverse electrical activity. The auxiliary conductor to the alternator had been severed and contained beading at the remaining section attached to the battery clamp. A portion of the conductor approximately six inches long had been consumed.

A view of the engine compartment.

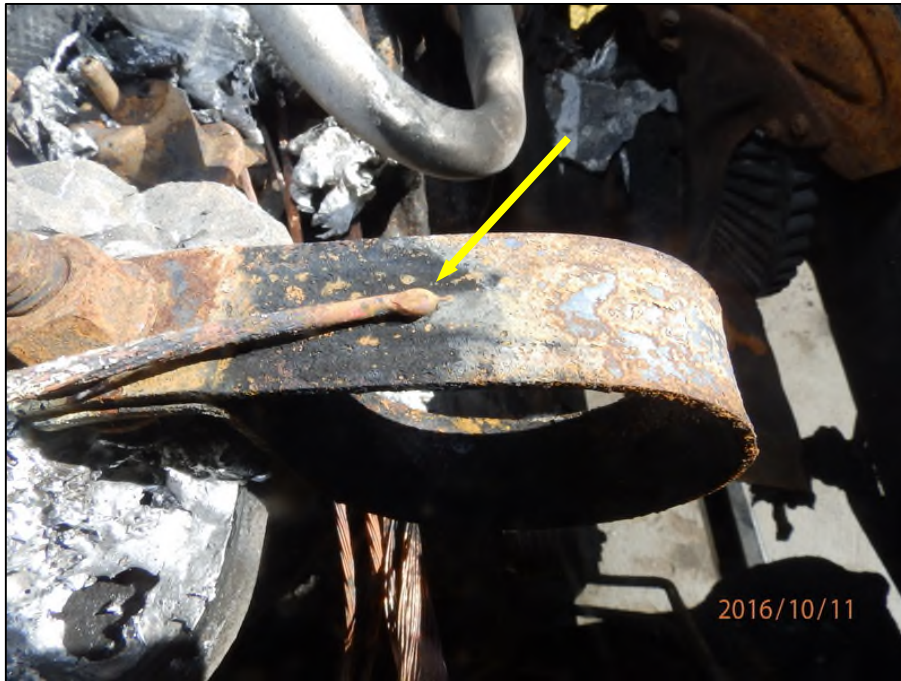
Photograph 3

Chaffing of the insulation of the positive conductor from the battery to the alternator, but mechanical damage or an existing splice could not be eliminated due to the severe fire damage and consumption of a section of the conductor.

A view of the positive conductor from the battery clamp.

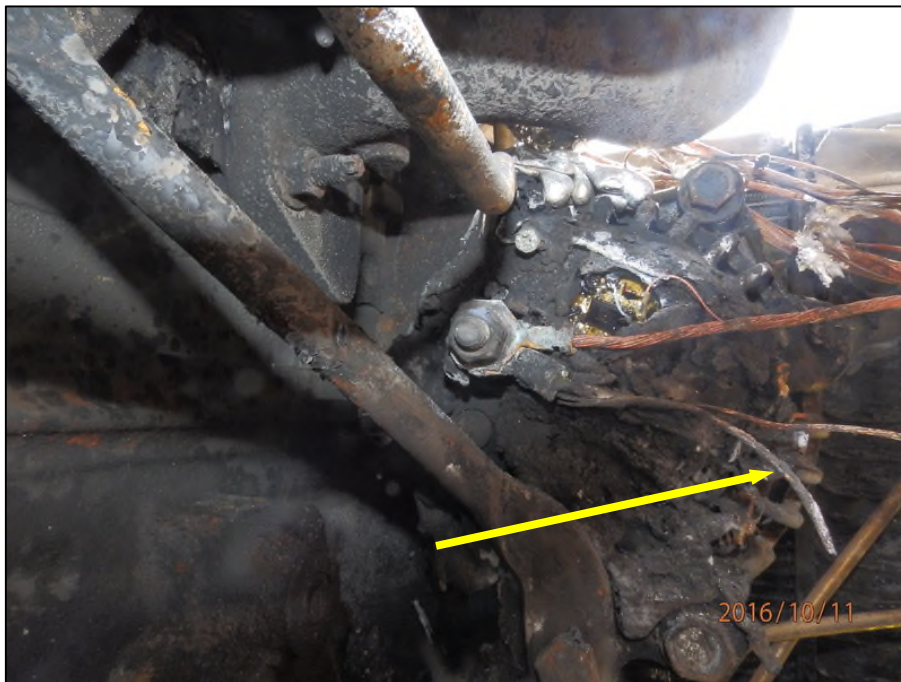
Photograph 4

A view of the conductor from the alternator.

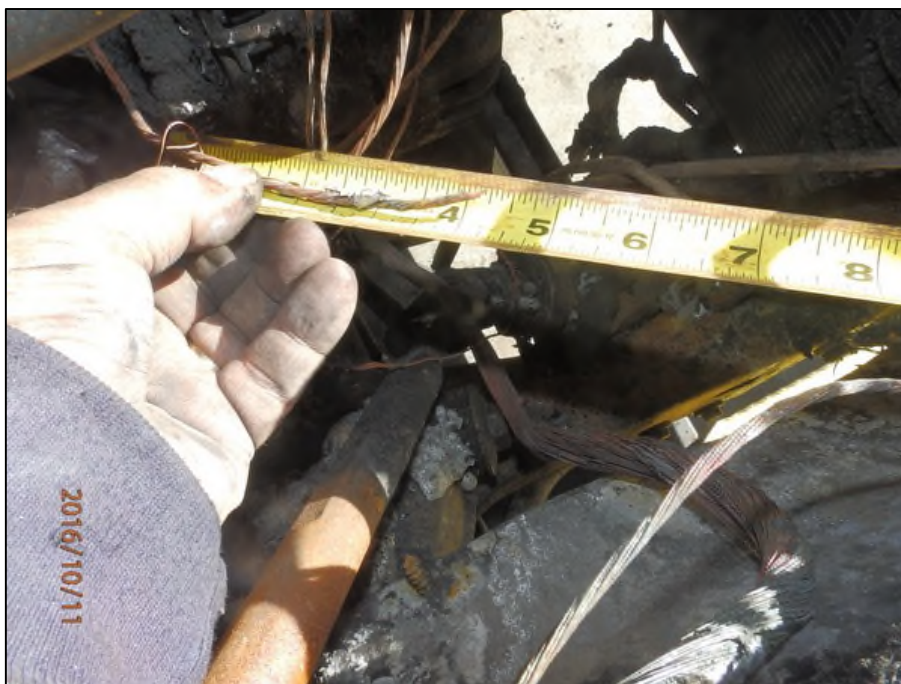
Photograph 5

A view of the distance between the two segments of the conductors.

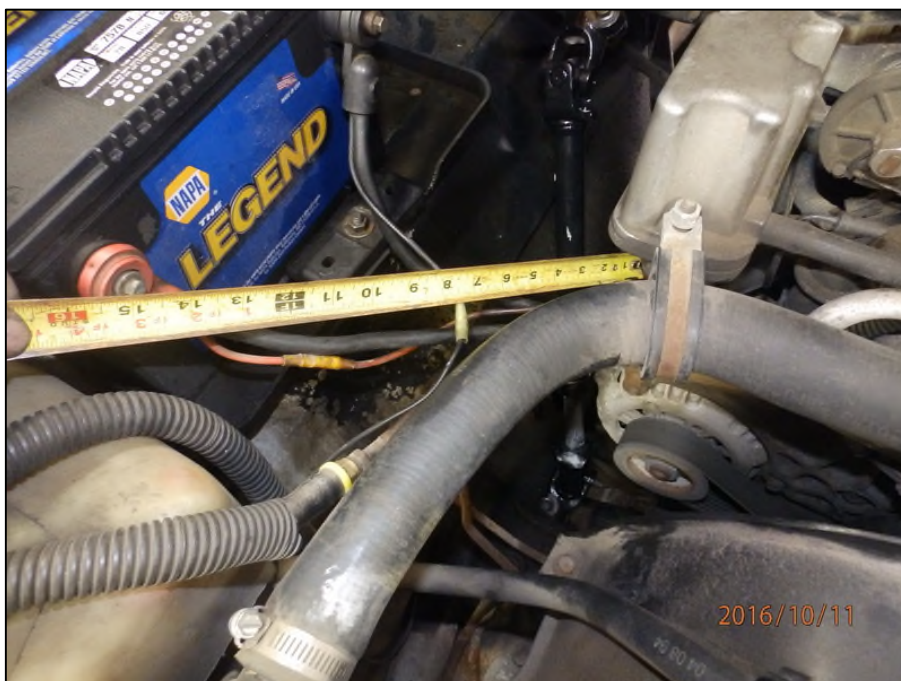
Photograph 6

A view of an exemplar.

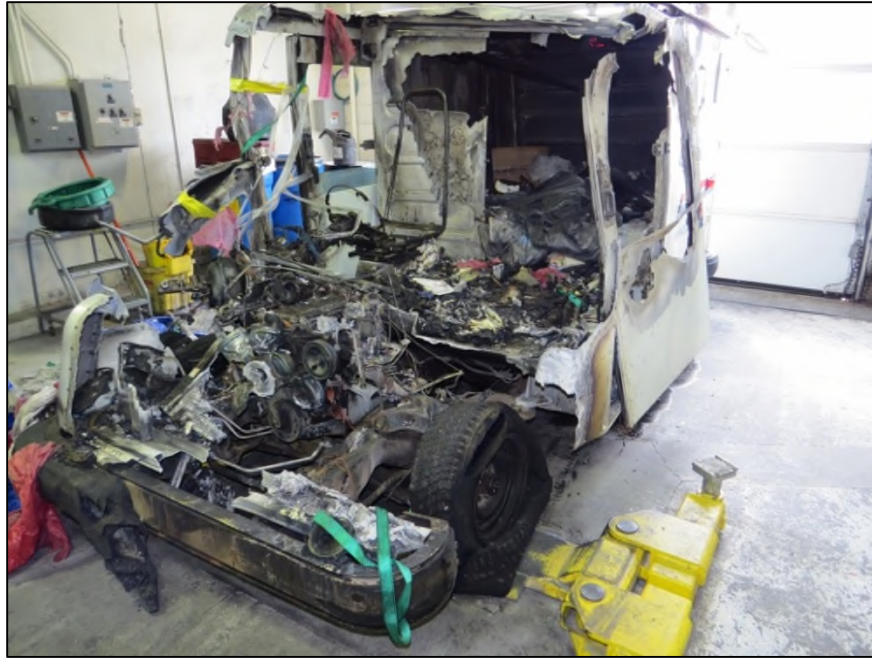
Photograph 1
Front of vehicle.

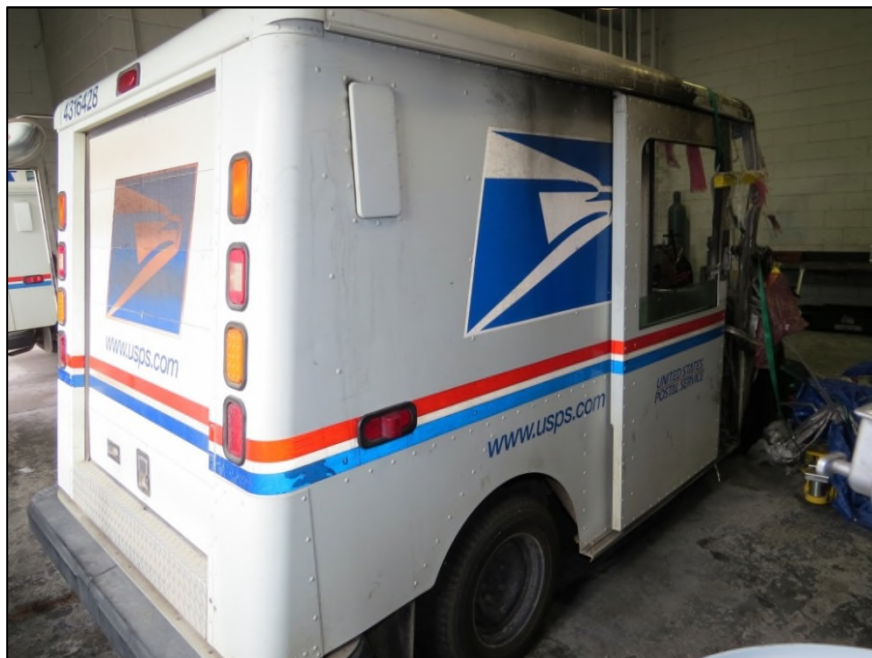
Photograph 2
Rear of vehicle.

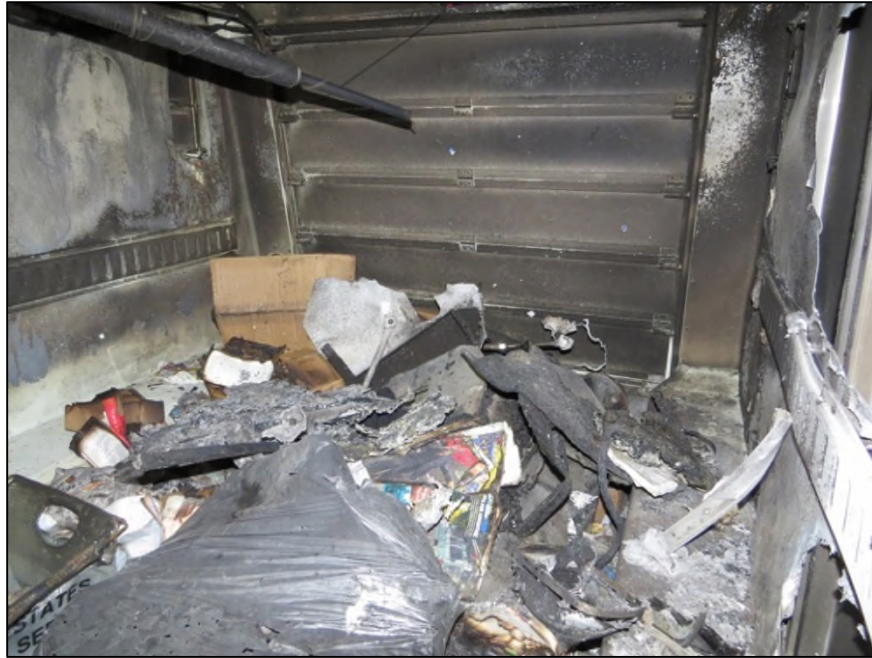
Photograph 3
Cargo Area.

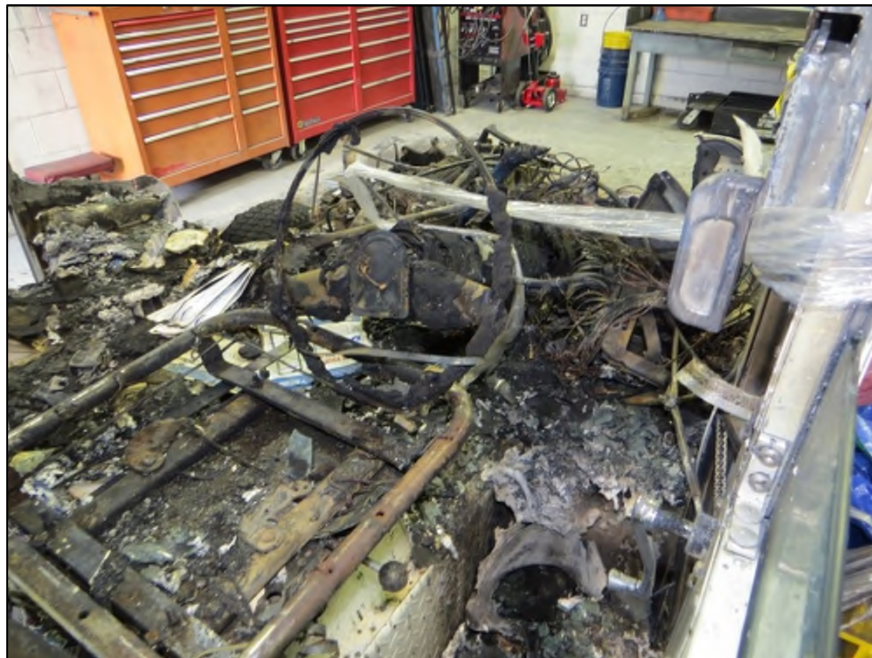
Photograph 4
Driver Seat and dashboard.

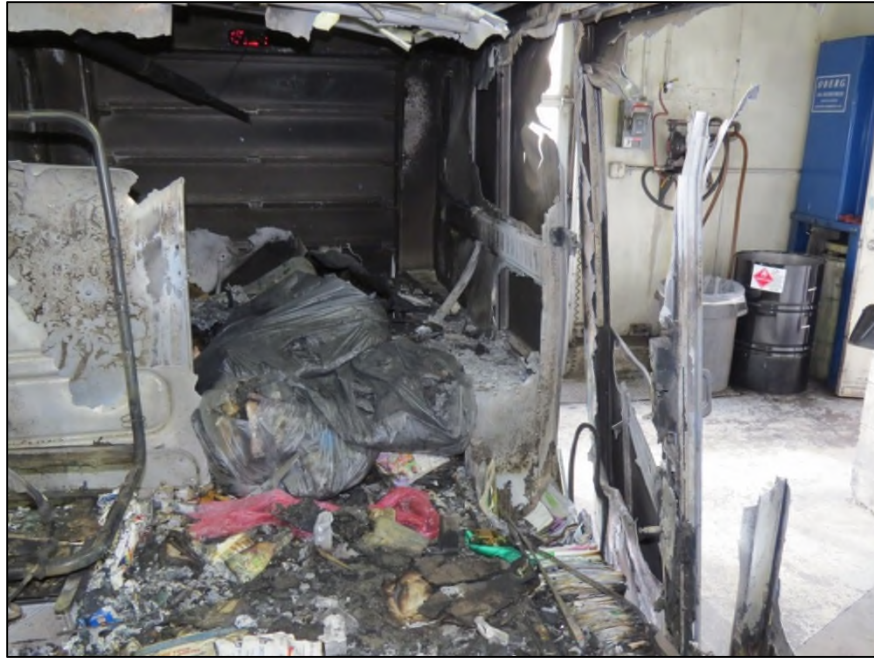
Photograph 5
Mail tray side.

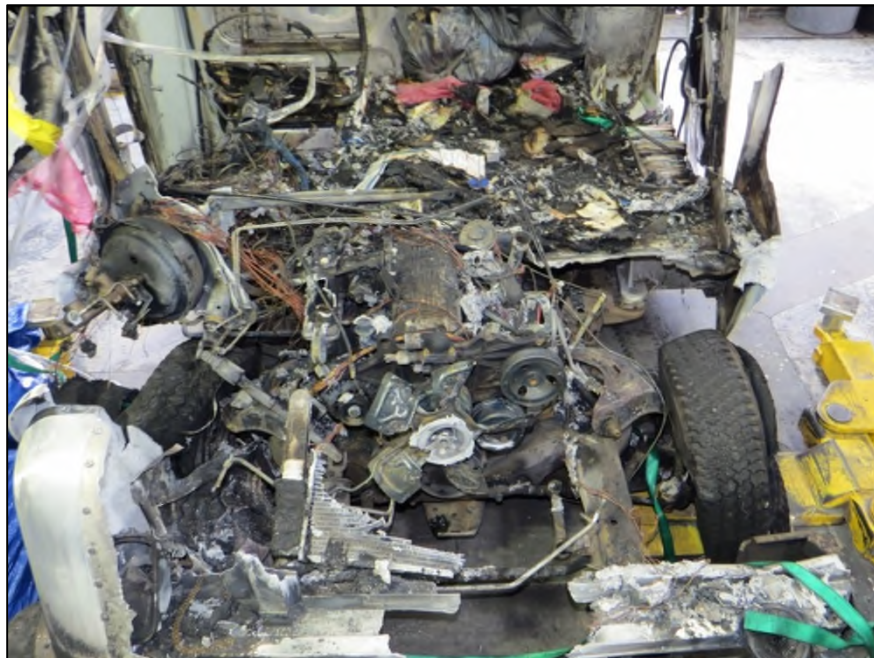
Photograph 6
Engine compartment.

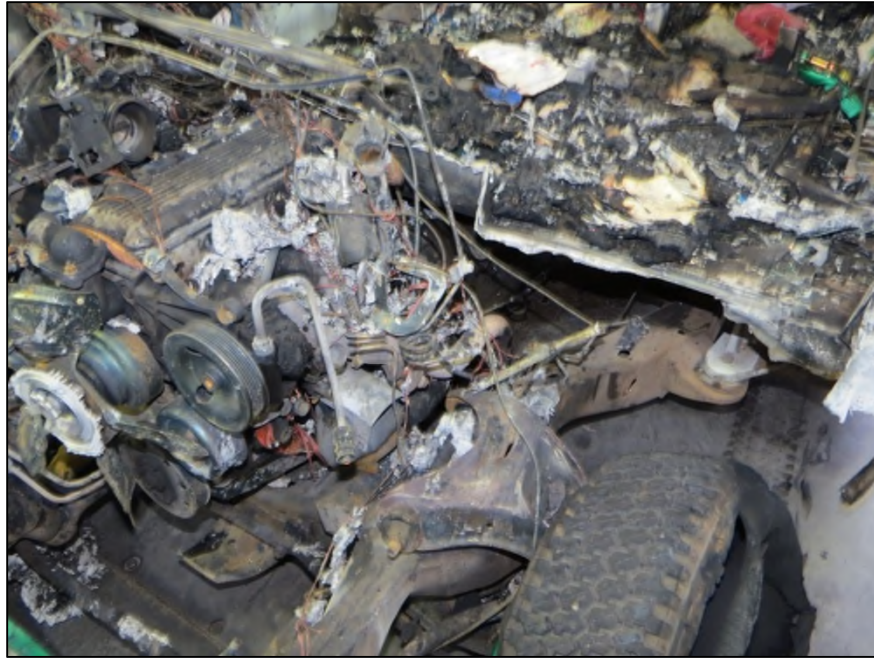
Photograph 7

Mail side of engine compartment.

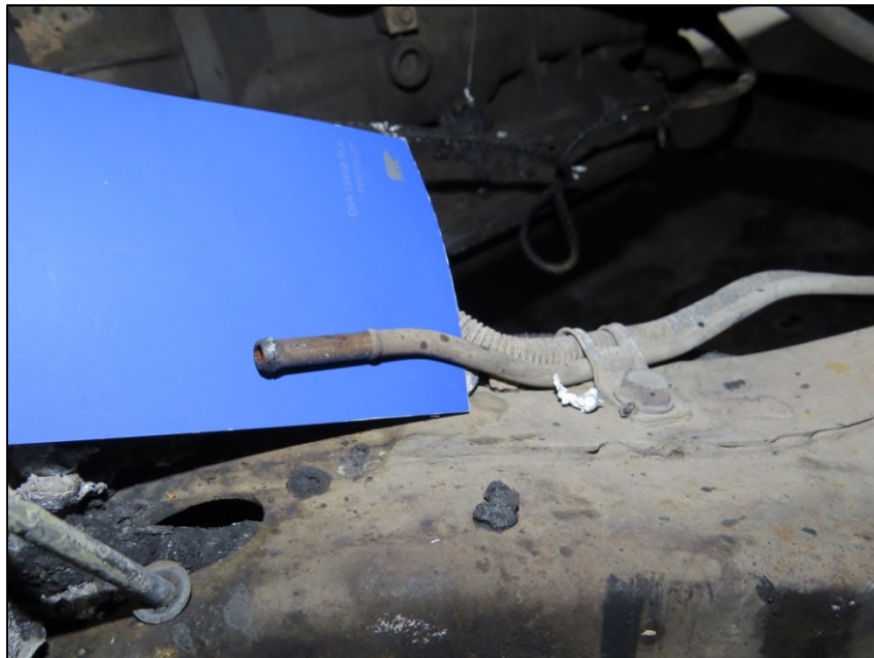
Photograph 8

Steel fuel line at rubber fuel line connection in area of fire origin.

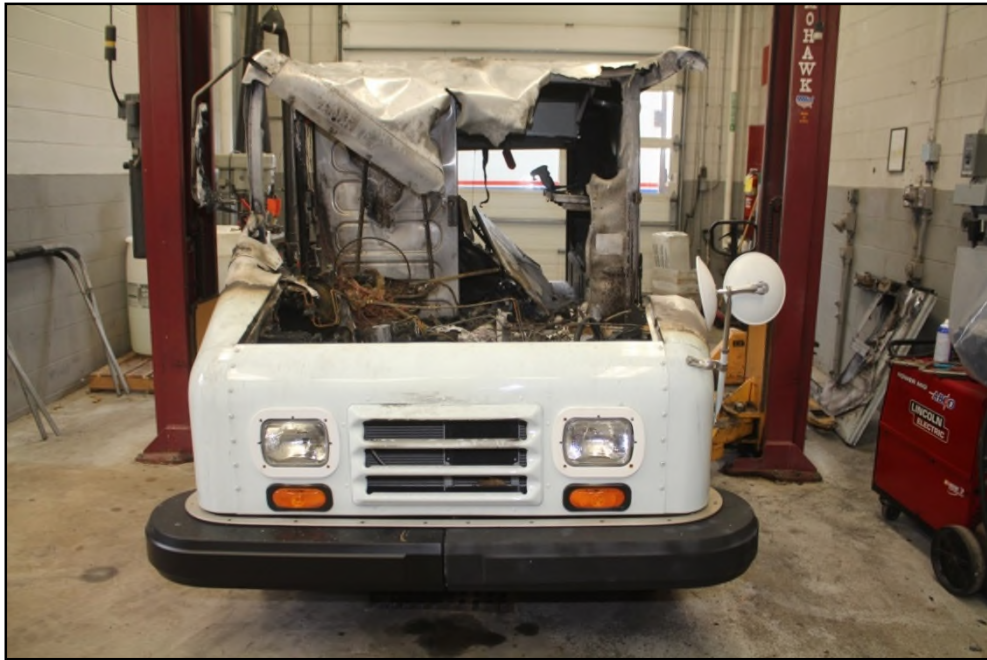
Photograph 1
Front of the LLV.

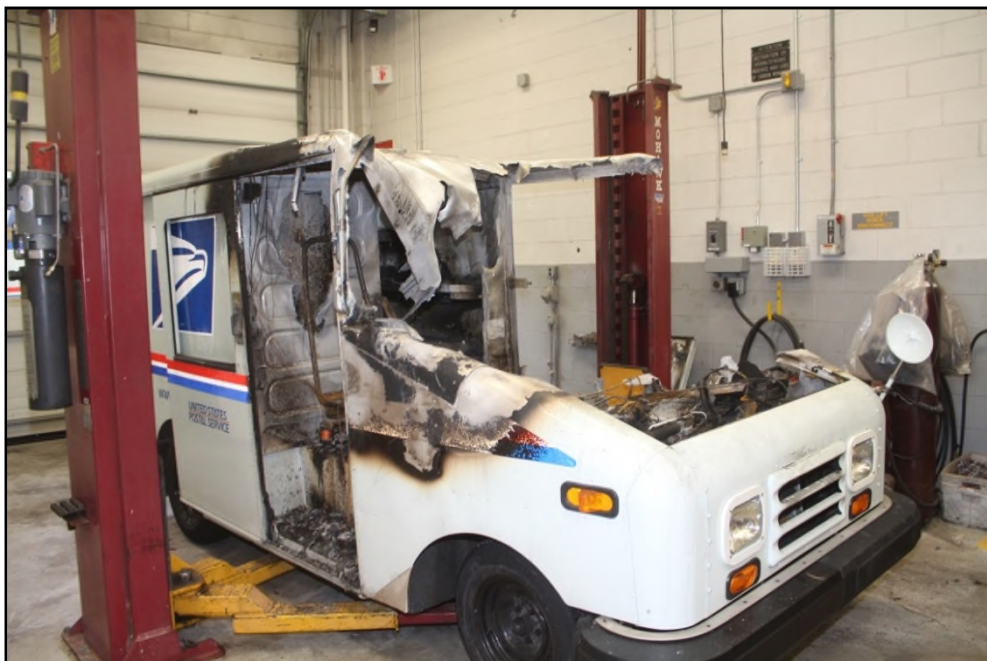
Photograph 2
Drivers side of the LLV.

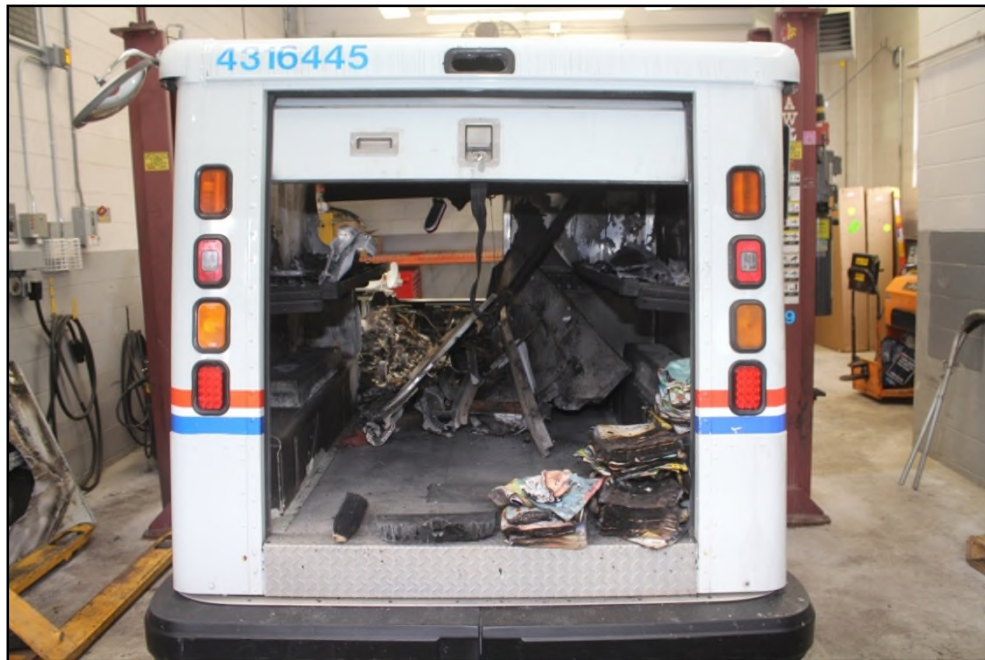
Photograph 3
Rear of the LLV.

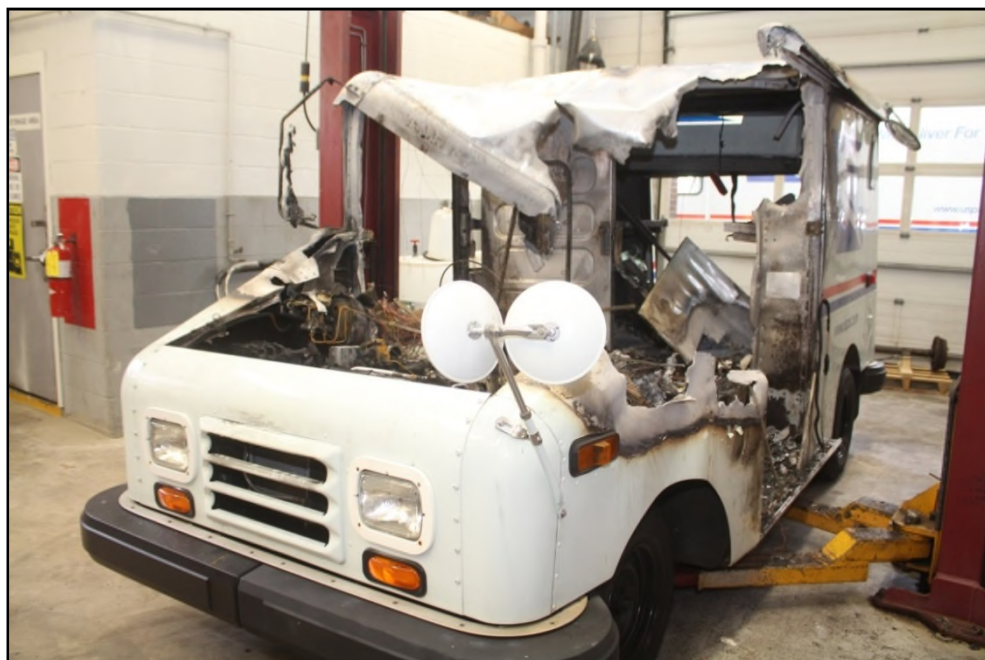
Photograph 4
Mail side of the LLV.

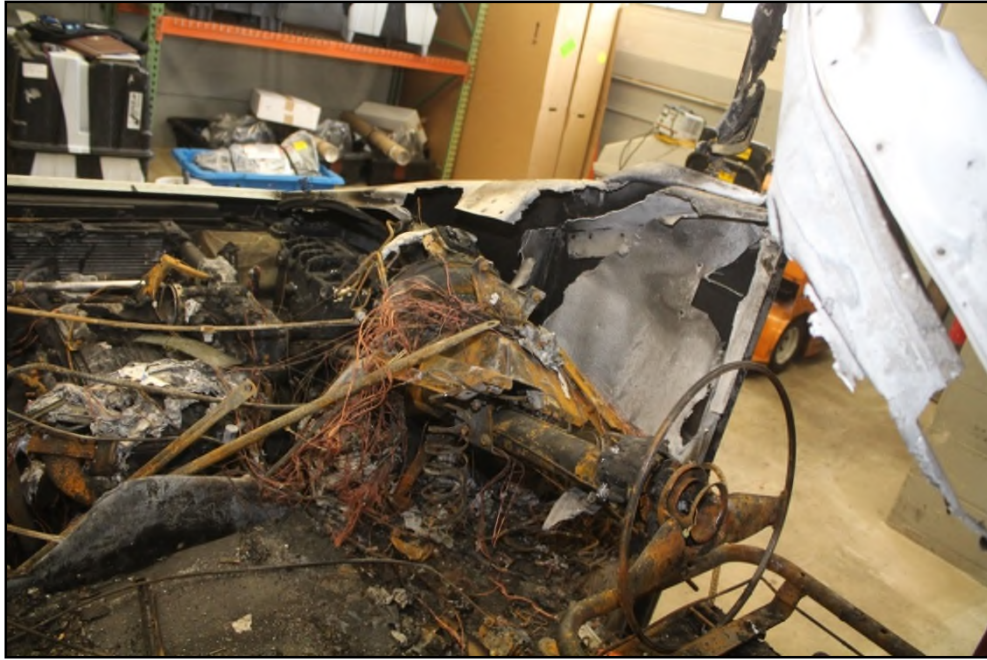
Photograph 5

Interior and view of the consumed dash area.

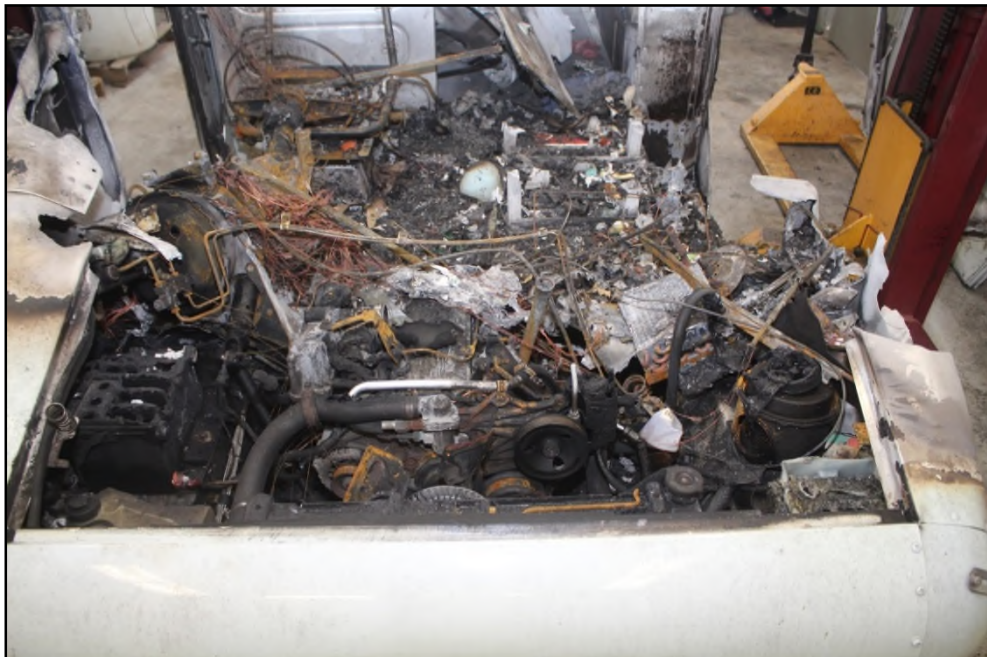
Photograph 6

Engine compartment.

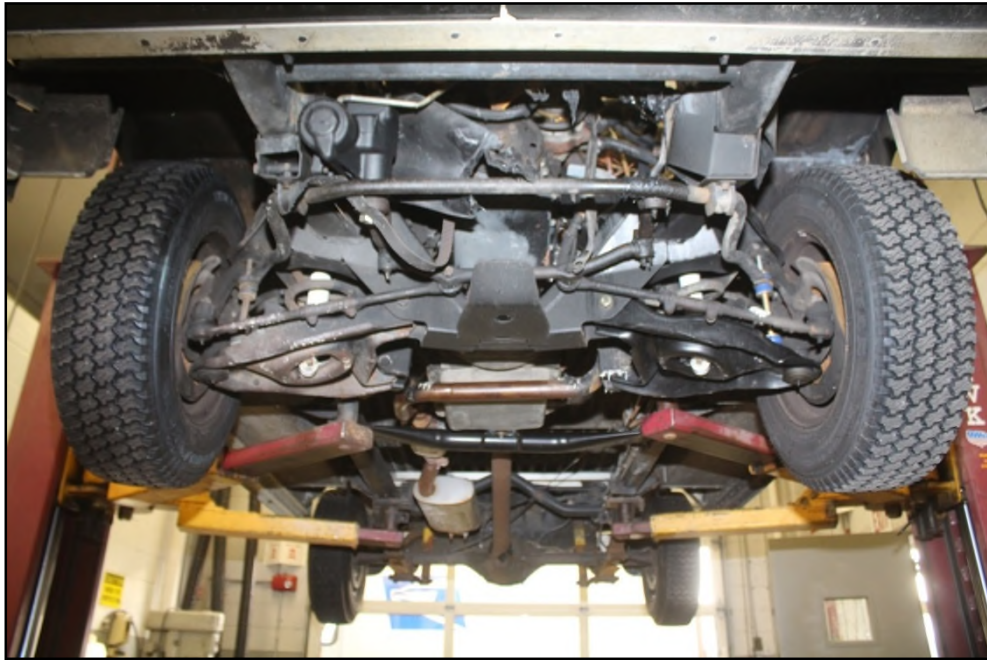
Photograph 7
Undercarriage of the LLV.

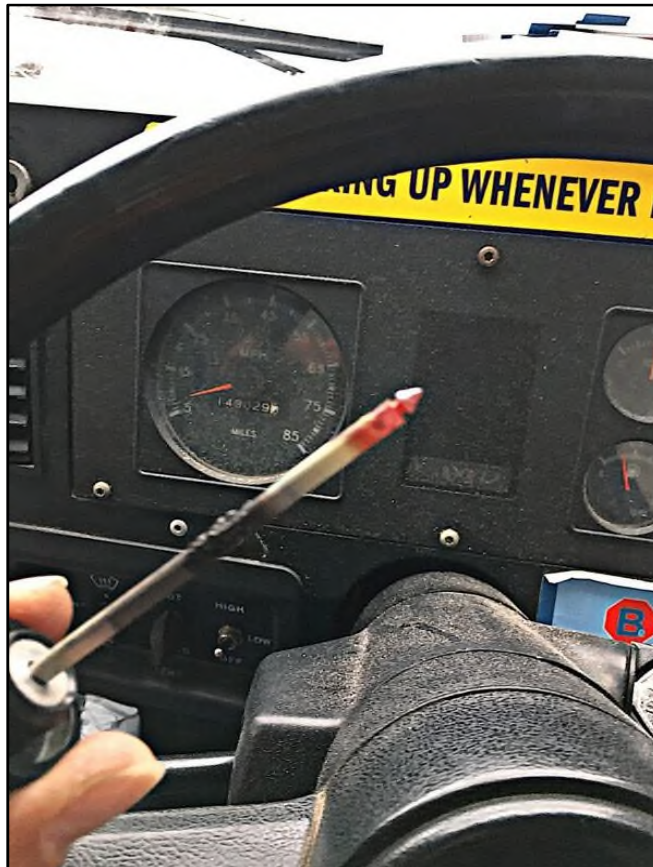
Photograph 8

Photograph of headlight switch just prior to fire provided by driver.

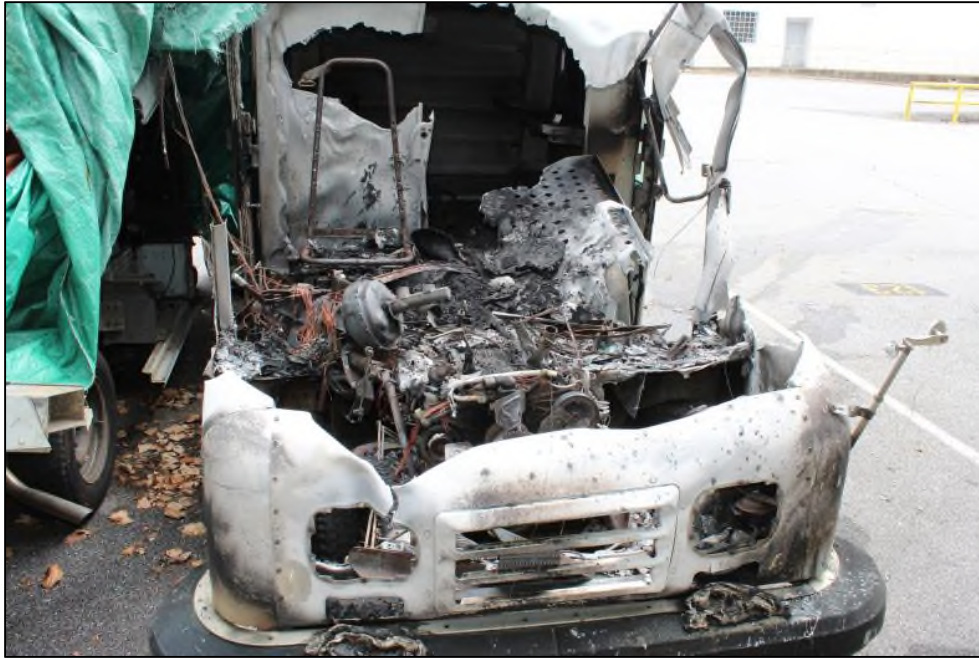
Photograph 1

Front view of the vehicle.

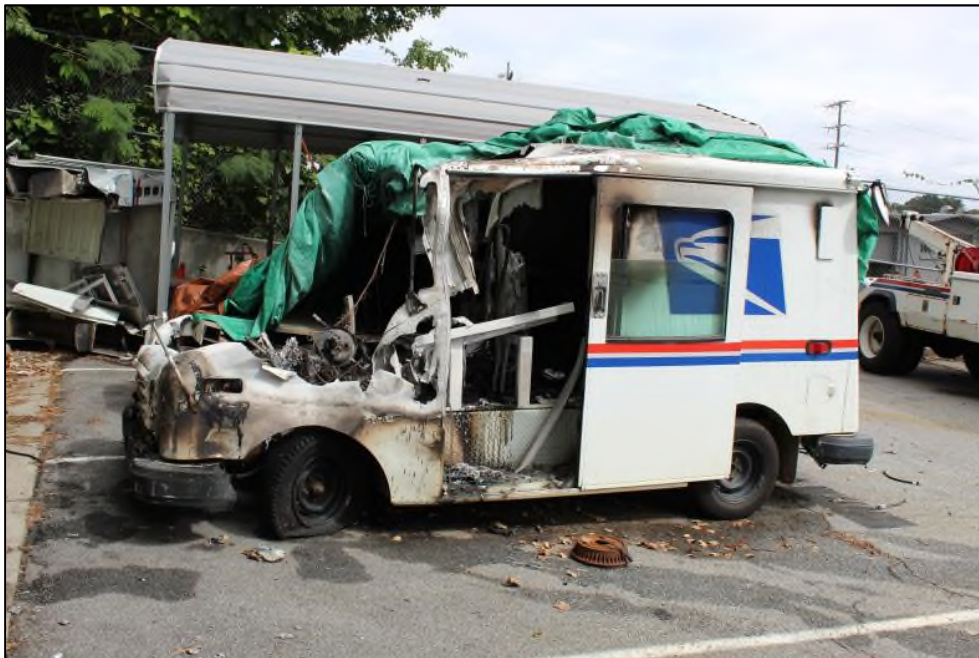
Photograph 2

Mail side of the vehicle.

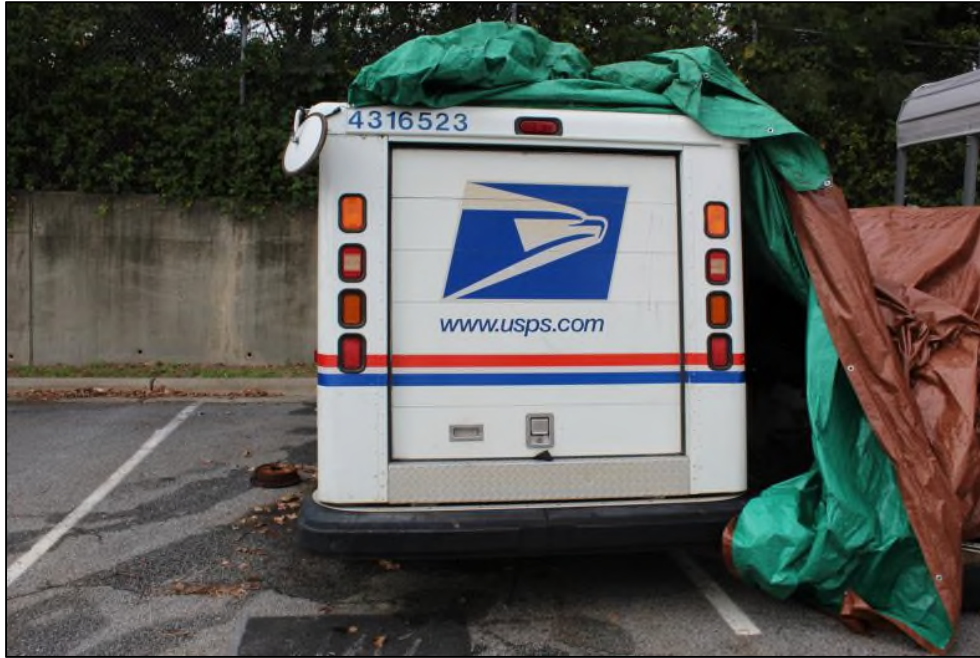
Photograph 3
Rear of the vehicle.

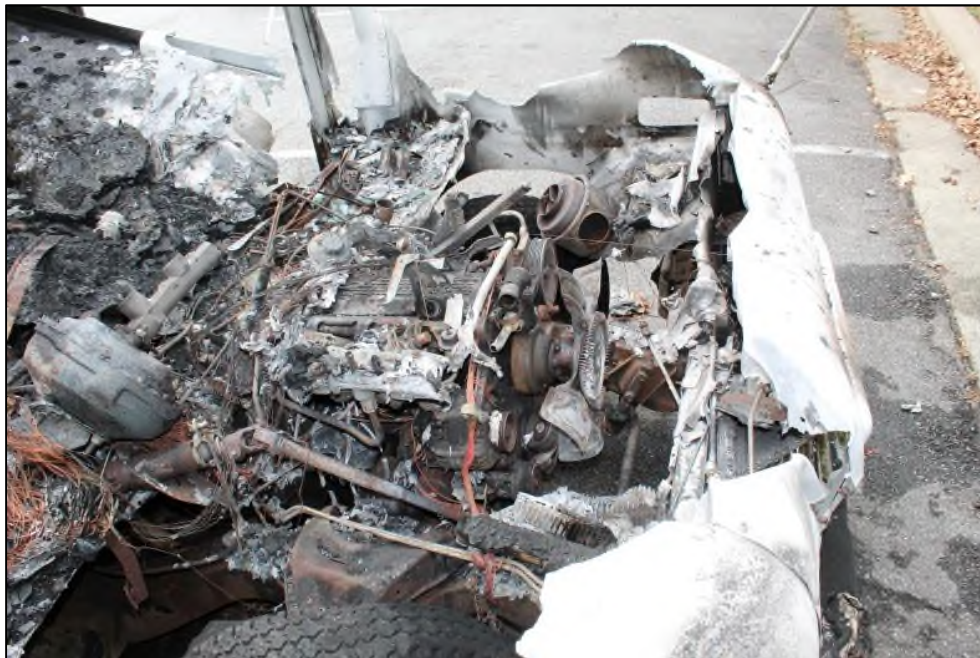
Photograph 4
Engine compartment of the vehicle.

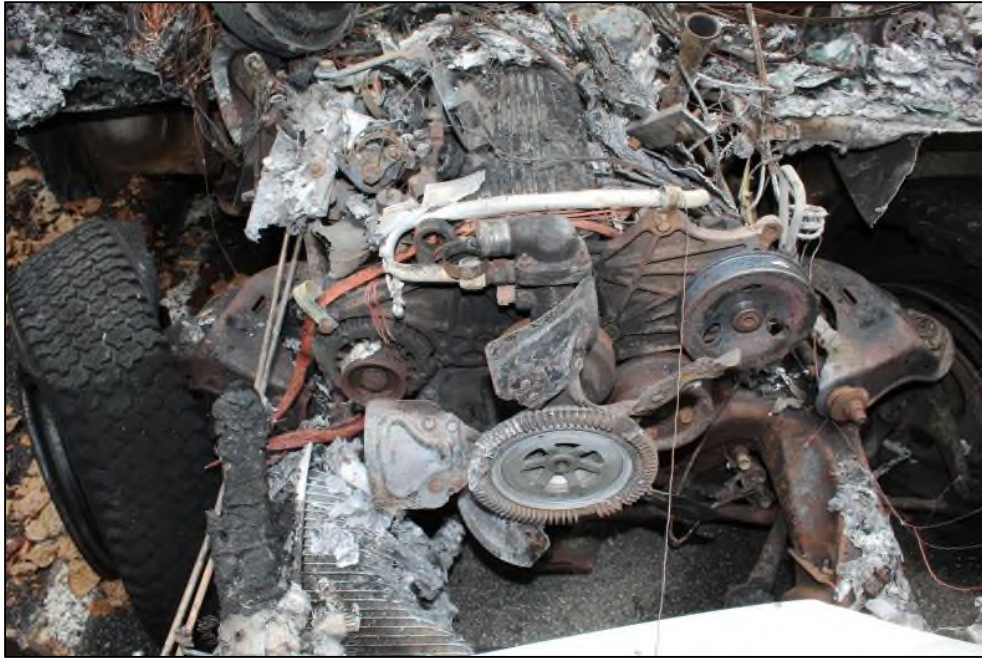
Photograph 5
Front of the engine.

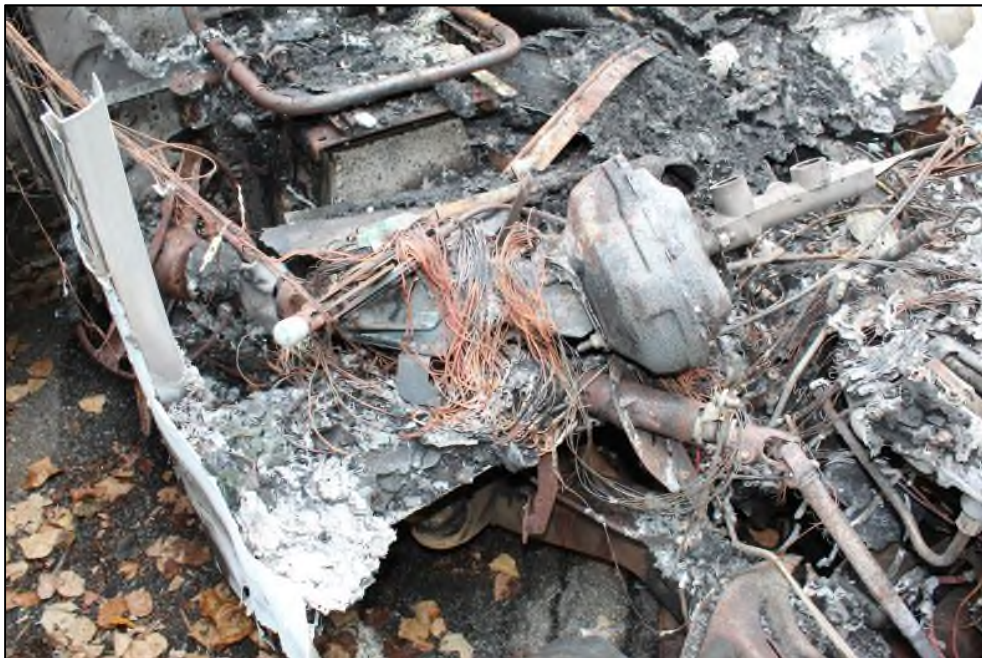
Photograph 6
Remains of the master brake cylinder, steering wheel, and steering column.

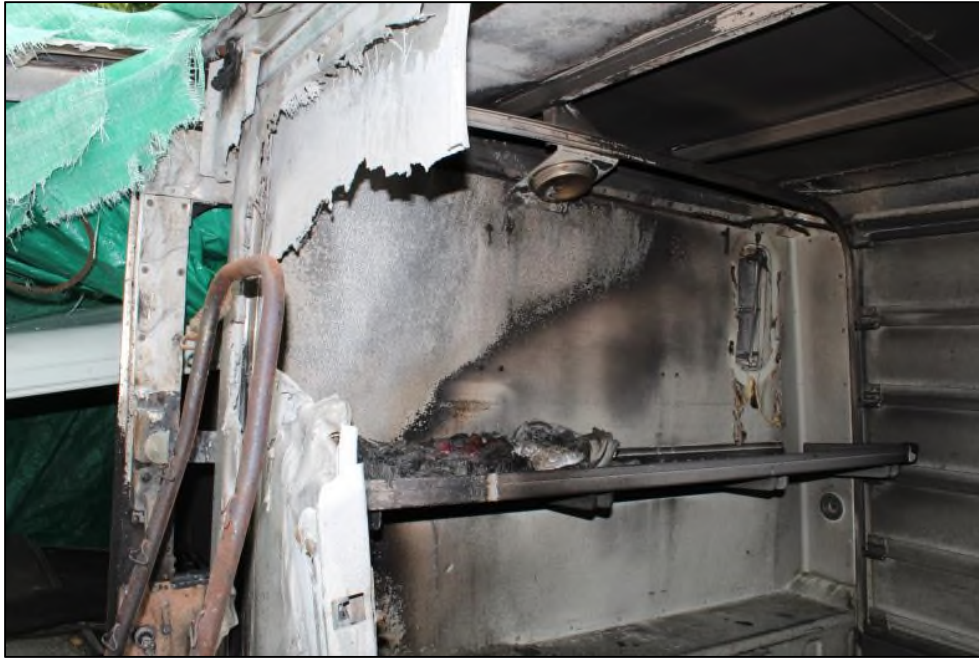
Photograph 7

Fire damage in the cargo compartment.

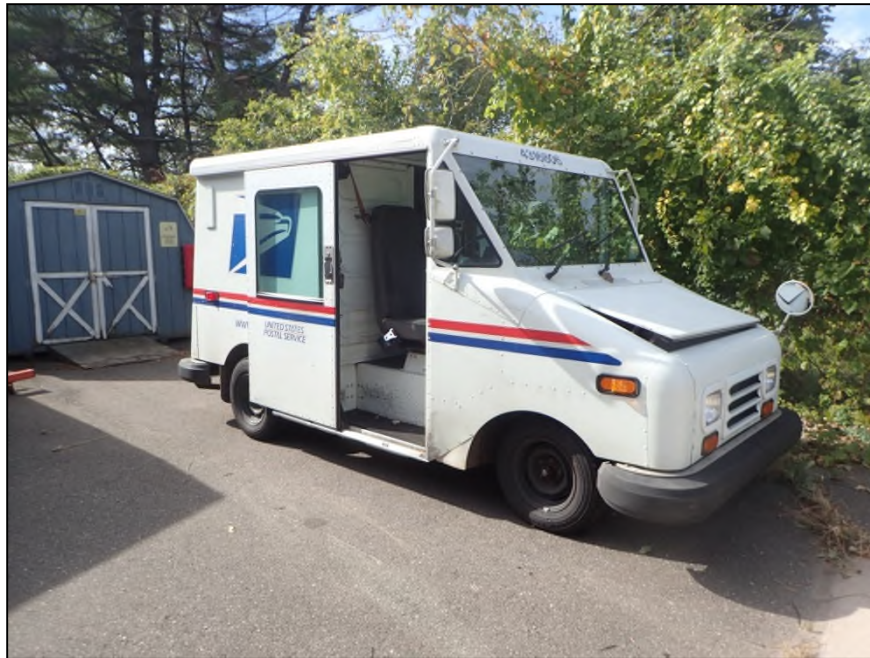
Photograph 1

Front and drivers side of LLV.

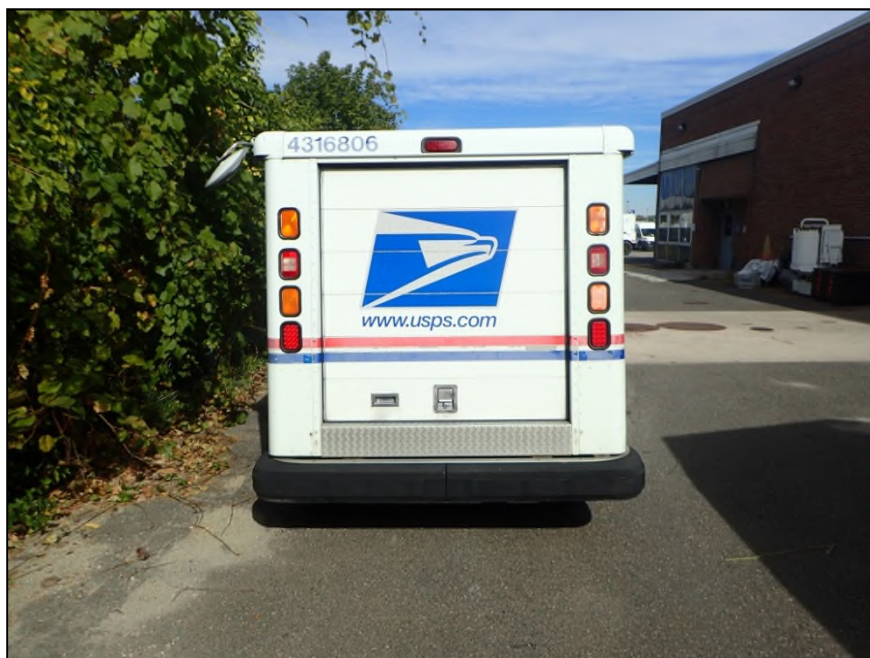
Photograph 2

Rear of LLV.

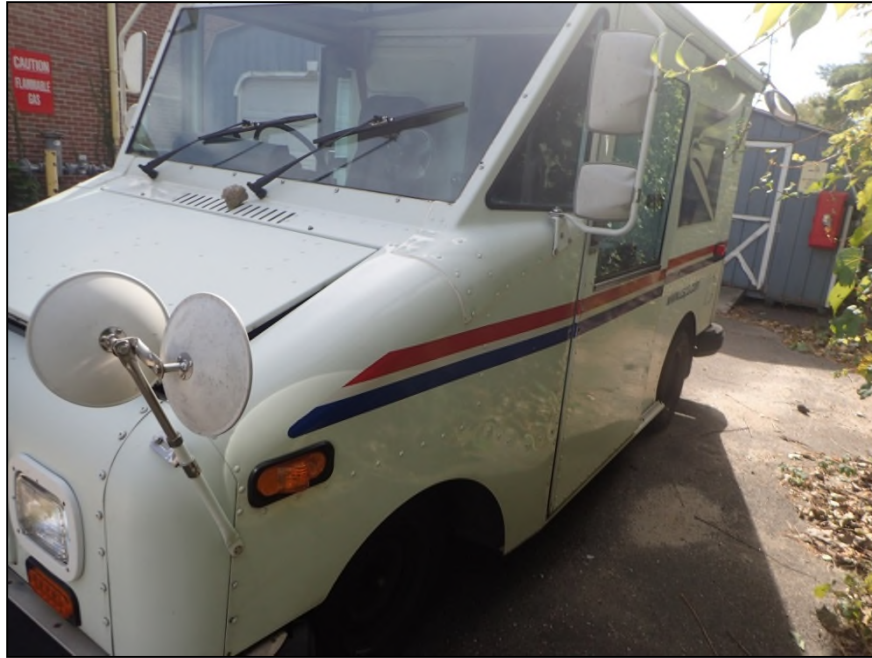
Photograph 3
Mail side of LLV.

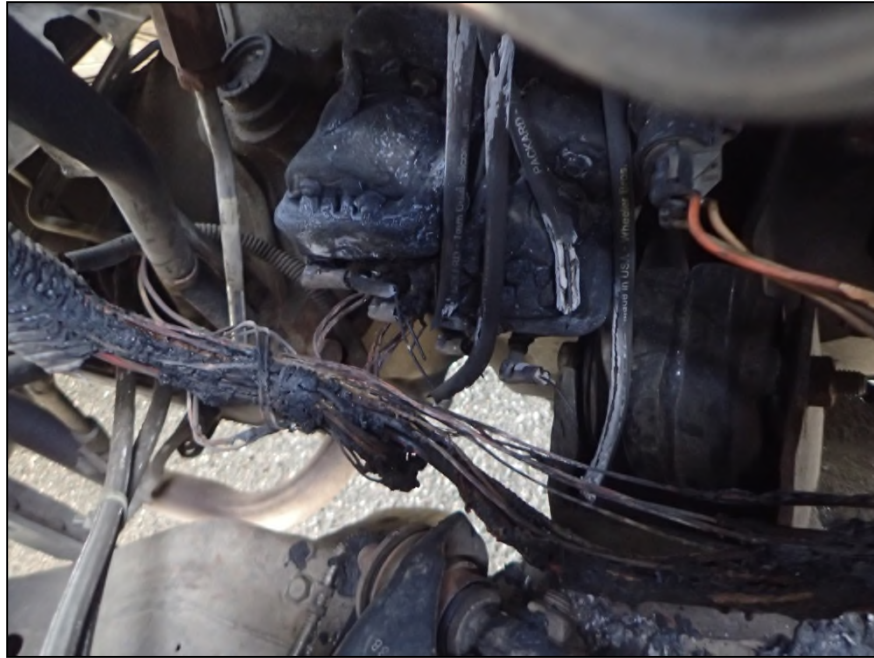
Photograph 5

Based on the observed patterns of fire damage, witness statements, and a systematic evaluation of the remaining physical evidence, it was determined that the fire originated in the engine compartment of the vehicle. The specific area origin was at or near the coil pack on the driver's side of the engine.

During our examination we determined that the most probable cause of the fire was an overheated coil pack. Reportedly, the coil ignition sets were replaced on October 1, 2018, two days prior to the fire.

Close up of fire damage at coil pack in engine compartment.

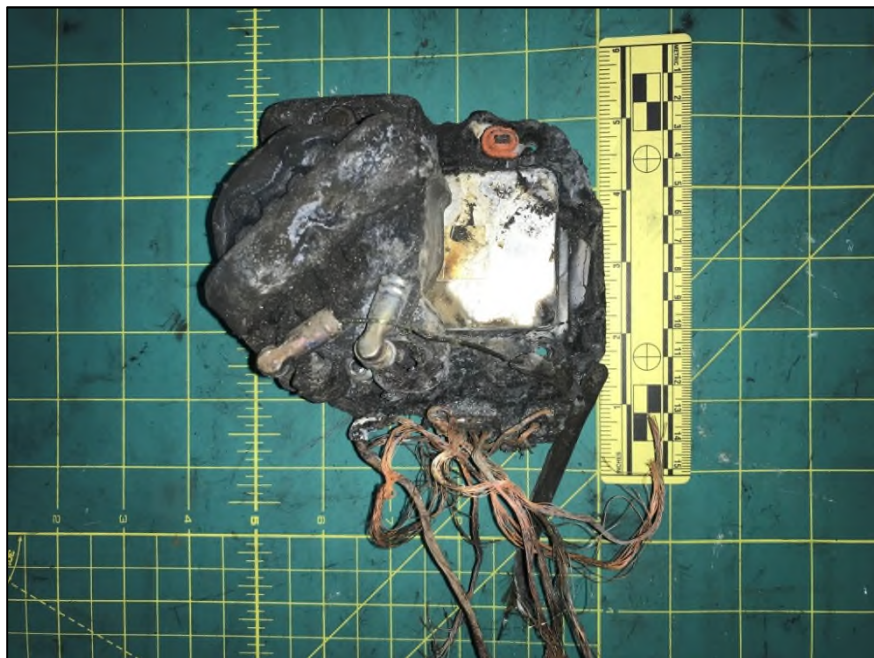
Photograph 6

3. The specific ignition sequence and cause of the fire was determined to be the direct result of a failure of the coil packs on the driver's side and the nearby wiring harness and some direction melting on the plastics of the alternator.

Fire damaged coil after removal.
